## Case Study – The Essential SNAP Seal & K-Commander® Conical Tracker

<b>Kinder Australia Product:</b>	<a href="#">The Essential SNAP Seal &amp; K-Commander® Conical Tracker</a>
<b>Product Category:</b>	Conveyor Skirting & Transfer   Conveyor Belt Tracking
<b>Location:</b>	New Zealand
<b>Conveyed Materials:</b>	Gypsum Rock
<b>Belt Width   Prod. Capacity:</b>	1200mm / 750mm / 650mm   Varies 1000 / 300 / 100 / 10
<b>Installation Date:</b>	Feb - October 2022

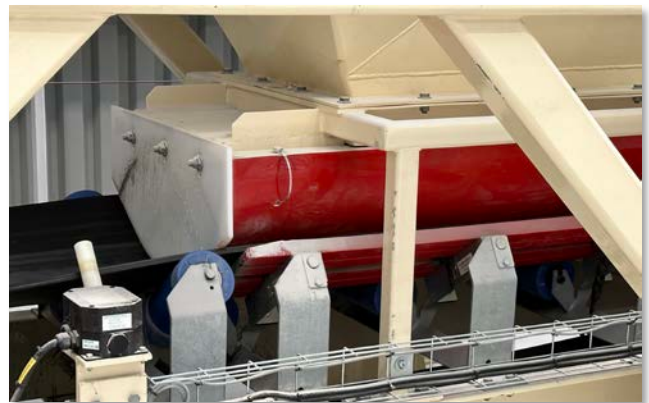
As part of the targeted dust / spillage solution, the design included Kinder's the [Essential SNAP Seal](#), belt support and skirting solution, seven in total within the conveyor system's seven primary load zone areas. Installing [K-Shield Impact Belt Support System](#) onto the biggest conveyor made sense as it was the taking the largest throughput and fullest impact.

For the lower throughput conveyors, the operator opted for the installation of Kinder's side skirting / belt support solution, [K-Containment® Seal](#), [K-Snap-Loc® Dust Seal](#) and [K-Sure® Belt Support System](#) with a rolling element.

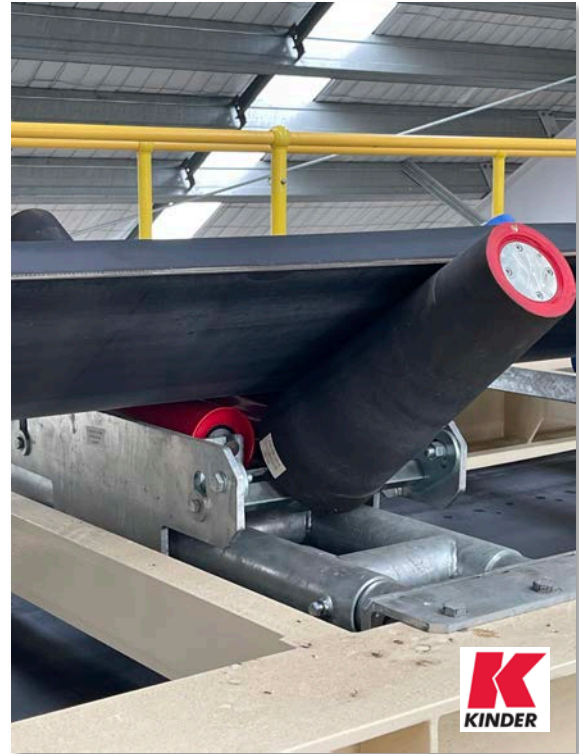
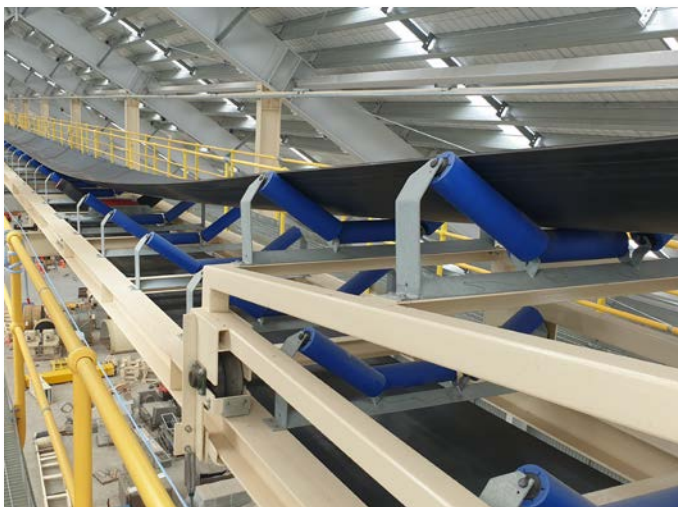
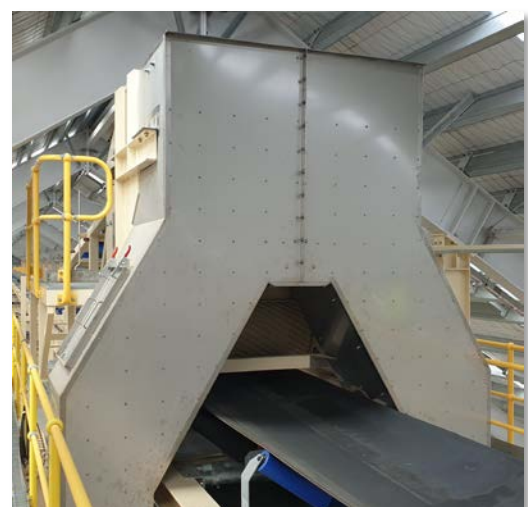
To elaborate, the intake conveyor is 260m long, including a 100m incline section. The last 100m uses a tripper car to discharge the gypsum into the storage hall via a dual chute, which requires lifting the belt anywhere along this length.

There was not a lot of room between the chutes as space was at a premium. Traditional trough trackers with side rollers would not allow the belt to lift as required, and many other conical style trackers have outer supports that are too wide to fit inside the tripper frame and chute.

PW Engineering didn't want to risk leaving the belt untracked over this length, particularly as it is picked up and put back down by the tripper at a variable location. In this instance, K-Commander® Conical Trackers were the perfect fit, six K-Commander® Conical Trackers were easily bolted into place and fitted nicely between the chutes.

Keeping the belt correctly tracked along the tripper path will elevate the overall reliability of the conveying process. Thanks to the K-Commander® Conical Tracker, proprietary designed and engineered by Kinder, conveyor reliability is assured.

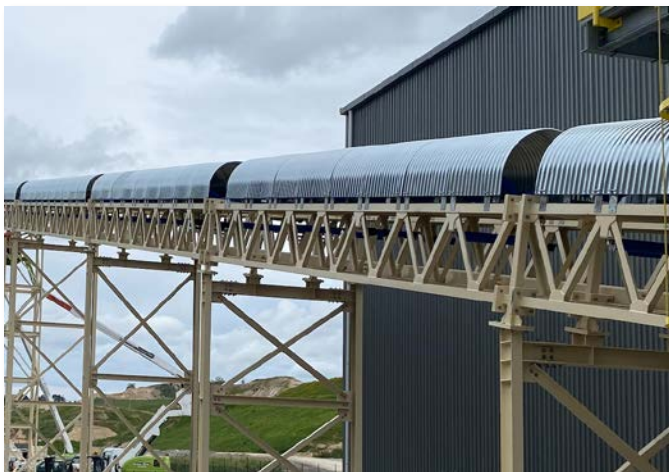
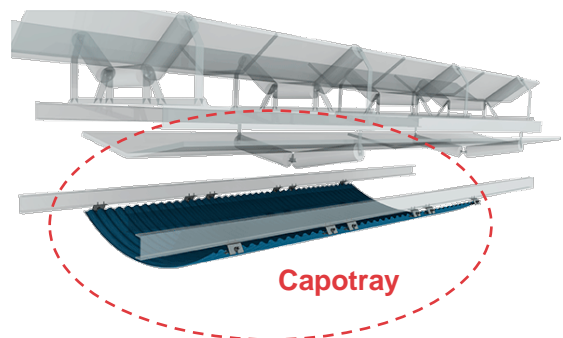
With conveyor safety also at the core a total of 575 metres of [K-AllShelter® Capotex Conveyor Covers](#) was installed as an effective way of reducing dust emissions from the conveyor system.

The conveyor covers also are highly effective in providing a physical barrier and protecting maintenance staff from the health risks of uncontained dust, reducing the environmental impact of dust emissions, as well as keeping conveyed product dry from rain.

535 metres of Capotray was also installed in conveyor areas over a certain height, where falling debris can lead to serious worker injuries if not contained.
