CASE STUDY: K-Containment Seal

Kinder Australia Product:	<u>K-Containment Seal</u>
Product Category:	Conveyor Skirting and Sealing
Location:	Auckland, New Zealand
Conveyed Materials:	Aggregate for Concrete Manufacture
Conveyed Belt Width/Speed:	900mm / 1 metre per sec
Rate / tonnes per hour	200
Installation Date:	April 2017

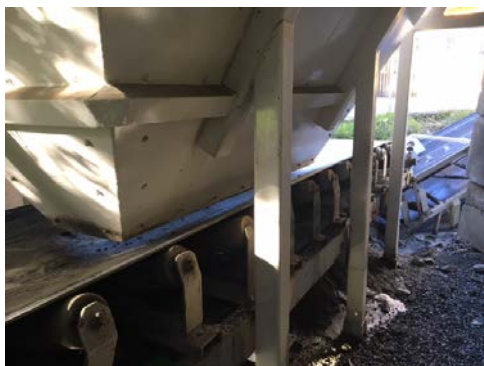
RIGHT
Image
BEFORE Installation

The concrete batching plant utilised standard trough bases and steel rollers. With no effective skirting & sealing system in place, the site identified two major challenges to overcome. Excessive material spillage was a primary issue in and around the conveyor as well as the conveyor being fed onto. This resulted in production slowdowns, with maintenance time, resources and additional costs directed towards cleaning up the excessive material spillage.

Material build up on the conveyor system was also identified, causing inefficient belt tracking, which in turn impacted on the operations continuous productivity aspirations.

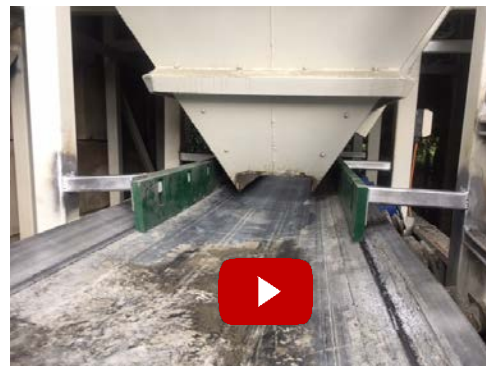
LEFT
Image
AFTER Installation

Satisfactory reports from the concrete batching plant highlight **K-Containment Seal's** exceptional product performance and its effectiveness in controlling material spillage, with maintenance crew commenting "*virtually no material spillage evident around the skirting area*". Cleaning up and dumping excessive material spillage costs have now been eliminated and plant production levels have returned to normal.

The skirting and sealing overhaul also involved new frames to be installed in conjunction with packers to ensure 100% linear loading zone. Brackets were manufactured and welded to the existing bin structure, ensuring rigidity and superior product performance. Installation preparation and process was simple and production downtime was minimal to facilitate the changeover, with the whole installation process meeting the client's satisfaction.
