CASE STUDY: K-Sure® Belt Support System

Product:	K-Sure® Belt Support System
Product category:	Conveyor Belt Support
Location:	Tauranga, New Zealand
Conveyed materials:	80mm Hard Rock
Installation date:	November 2014

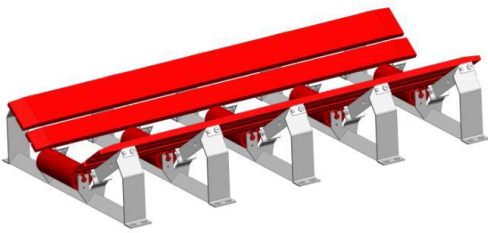
Above: Drawings of standard K-Sure® Belt Support System. Customised variations available to suit.

The solution to this problem is to provide support under the chute using a slider bed. By doing this any belt edge sag will be eliminated and the effectiveness of the skirting seal will be increased, so reducing the spillage.

The first step was to remove the existing impact rollers. The **K-Sure® Belt Support** was then positioned under the transfer point and installed. A design feature of the **K-Sure® Belt Support System** is that it can be retro-fitted, so the customer did not need to drill any holes, modify or fabricate any special parts. All items supplied were “off the shelf items”. The 2 man procedure took approximately **45 minutes** to complete. The belt now runs 100% flat, allowing the skirting to sit smoothly on the conveyor belt and **effectively contain the material load**.

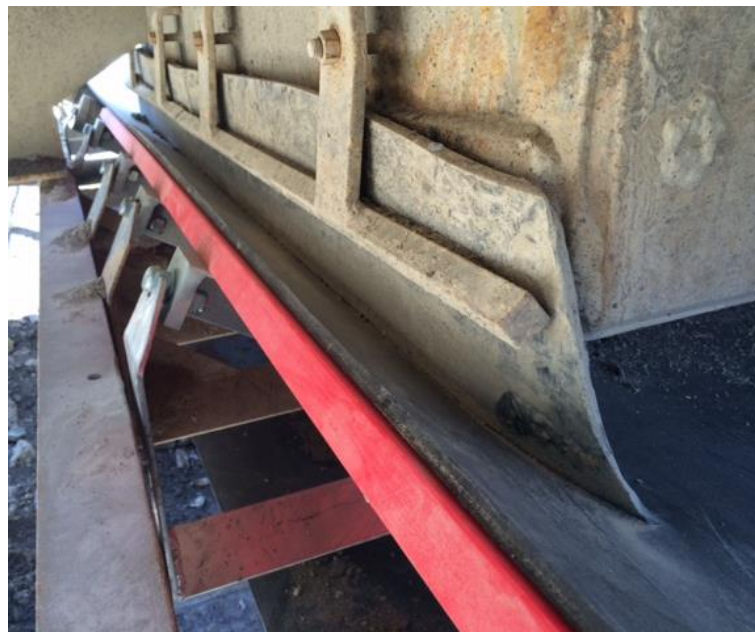
Right: K-Sure® Belt Support System after installation at customer's quarry site.

Our customer is extremely satisfied with both the performance of the **K-Sure® Belt Support** as well as the ease of its installation, and is impressed with how this has **improved the overall productivity of the conveyor system**.
